MERRIMACK RIVER BASIN
LYNDEBOROUGH, NEW HAMPSHIRE

SOUHEGAN RIVER WATERSHED
DAM NO. 8
NH 00474
NHWRB 147.28

PHASE I INSPECTION REPORT
NATIONAL DAM INSPECTION PROGRAM

AUGUST 1985

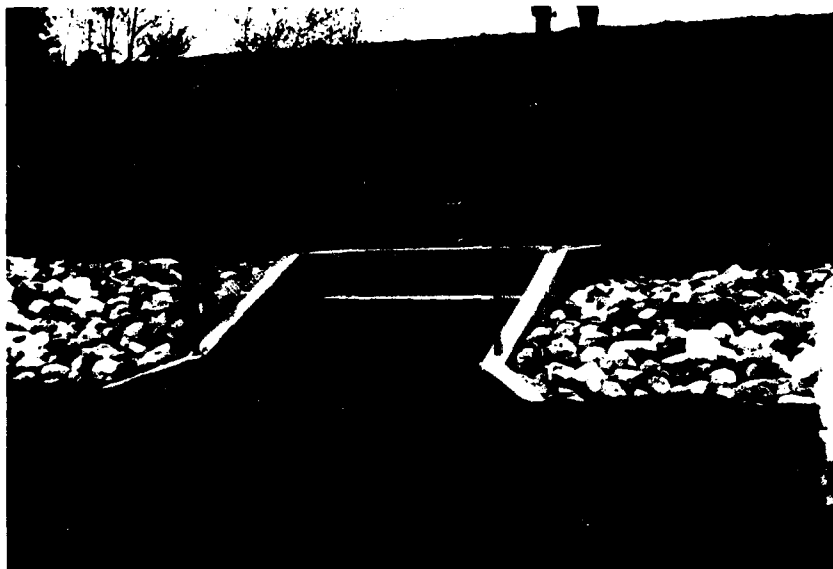
Tire ruts, 6 to 8 inches deep, were found along the downstream toe of the embankment at the right abutment and some minor erosion of the downstream slope was noted just above the impact basin. The upstream slope is not protected by riprap, but is in good condition.

5. View of impact basin showing minor erosion of embankment

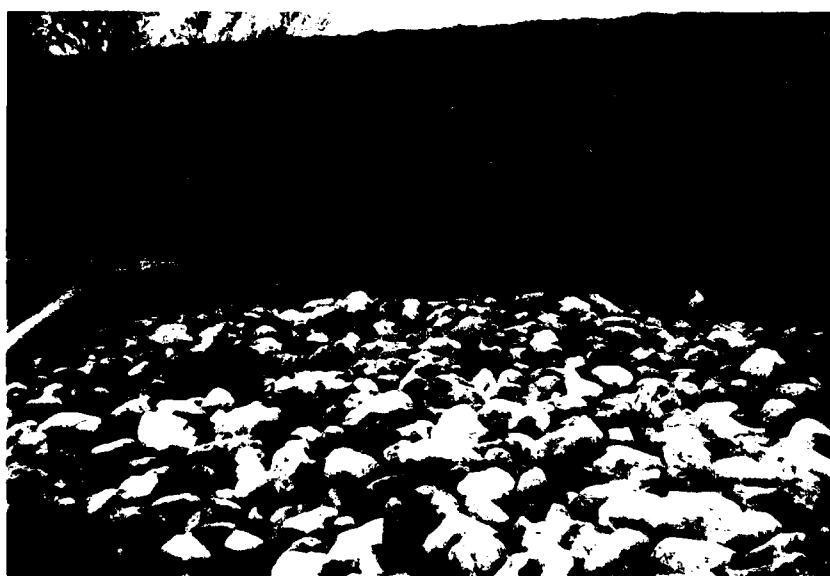
Small erosion gullies, 2 to 3 inches deep, were found in the downstream slope of the embankment.

6. Close up view of embankment erosion

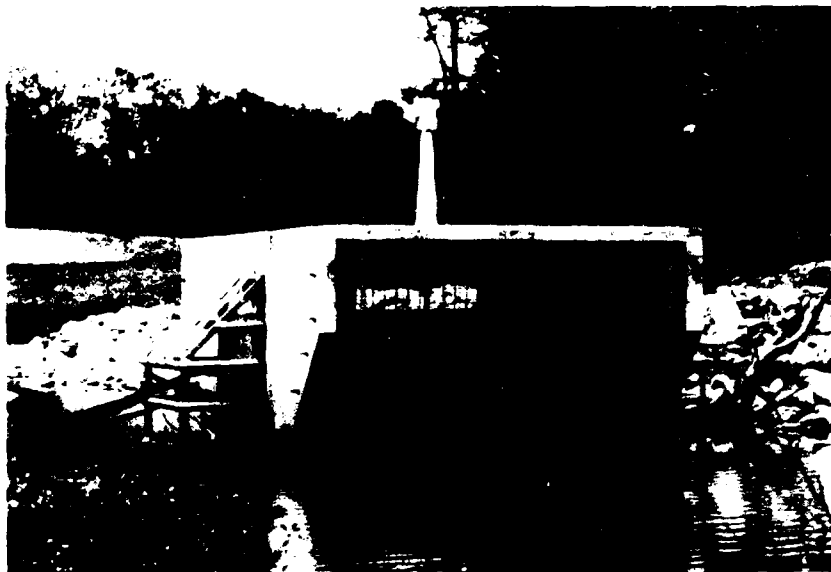
The structure is in good condition with no evidence of spalling, cracking, or efflorescence. The sluice gate bench stand is in good condition. The hand crank has been removed from the site to prevent unauthorized use. The trash racks are in good condition but are clogged with debris.

3. View of drop inlet structure showing high and low stage trash racks

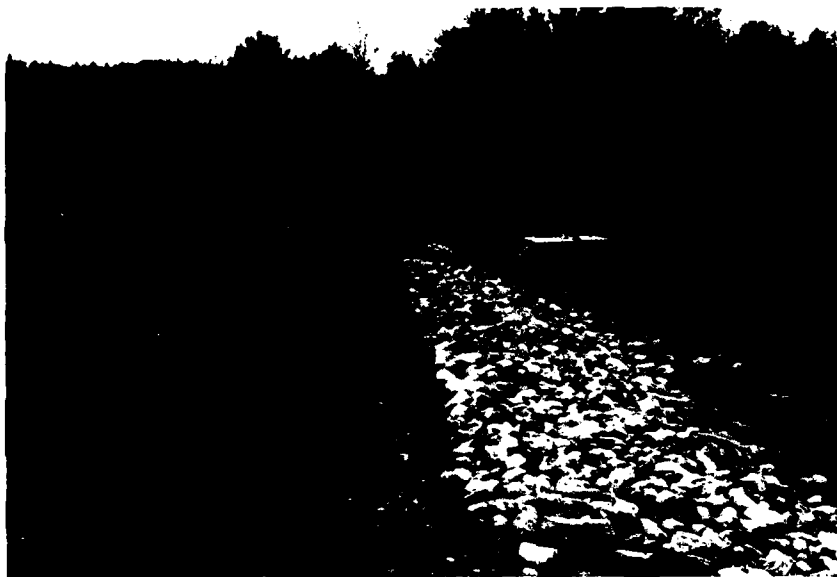
1. View of upstream slope of main dam
from left side

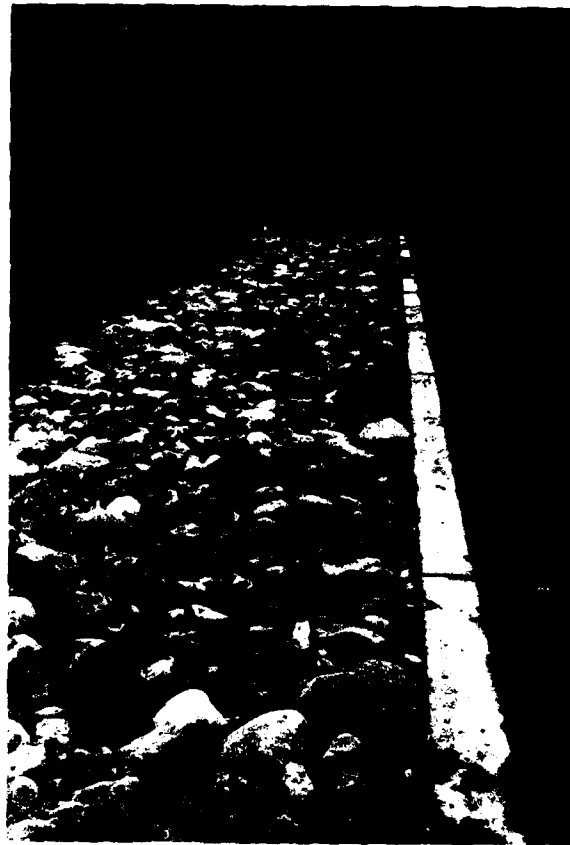
The emergency spillway sill is in good condition with some minor spalling of the exposed surface.

7. View of emergency spillway showing concrete sill with rock rip rap
